THE  
ONTARIO WATER RESOURCES  
COMMISSION  
REPORT ON  
MUNICIPAL WATER POLLUTION SURVEY  
VILLAGE OF MARKHAM  
COUNTY OF YORK

VILLAGE (TOWN) OF MARKHAM  
COUNTY OF YORK - 1963 - 1964

MUNICIPAL WATER POLLUTION SURVEY

Village of Markham

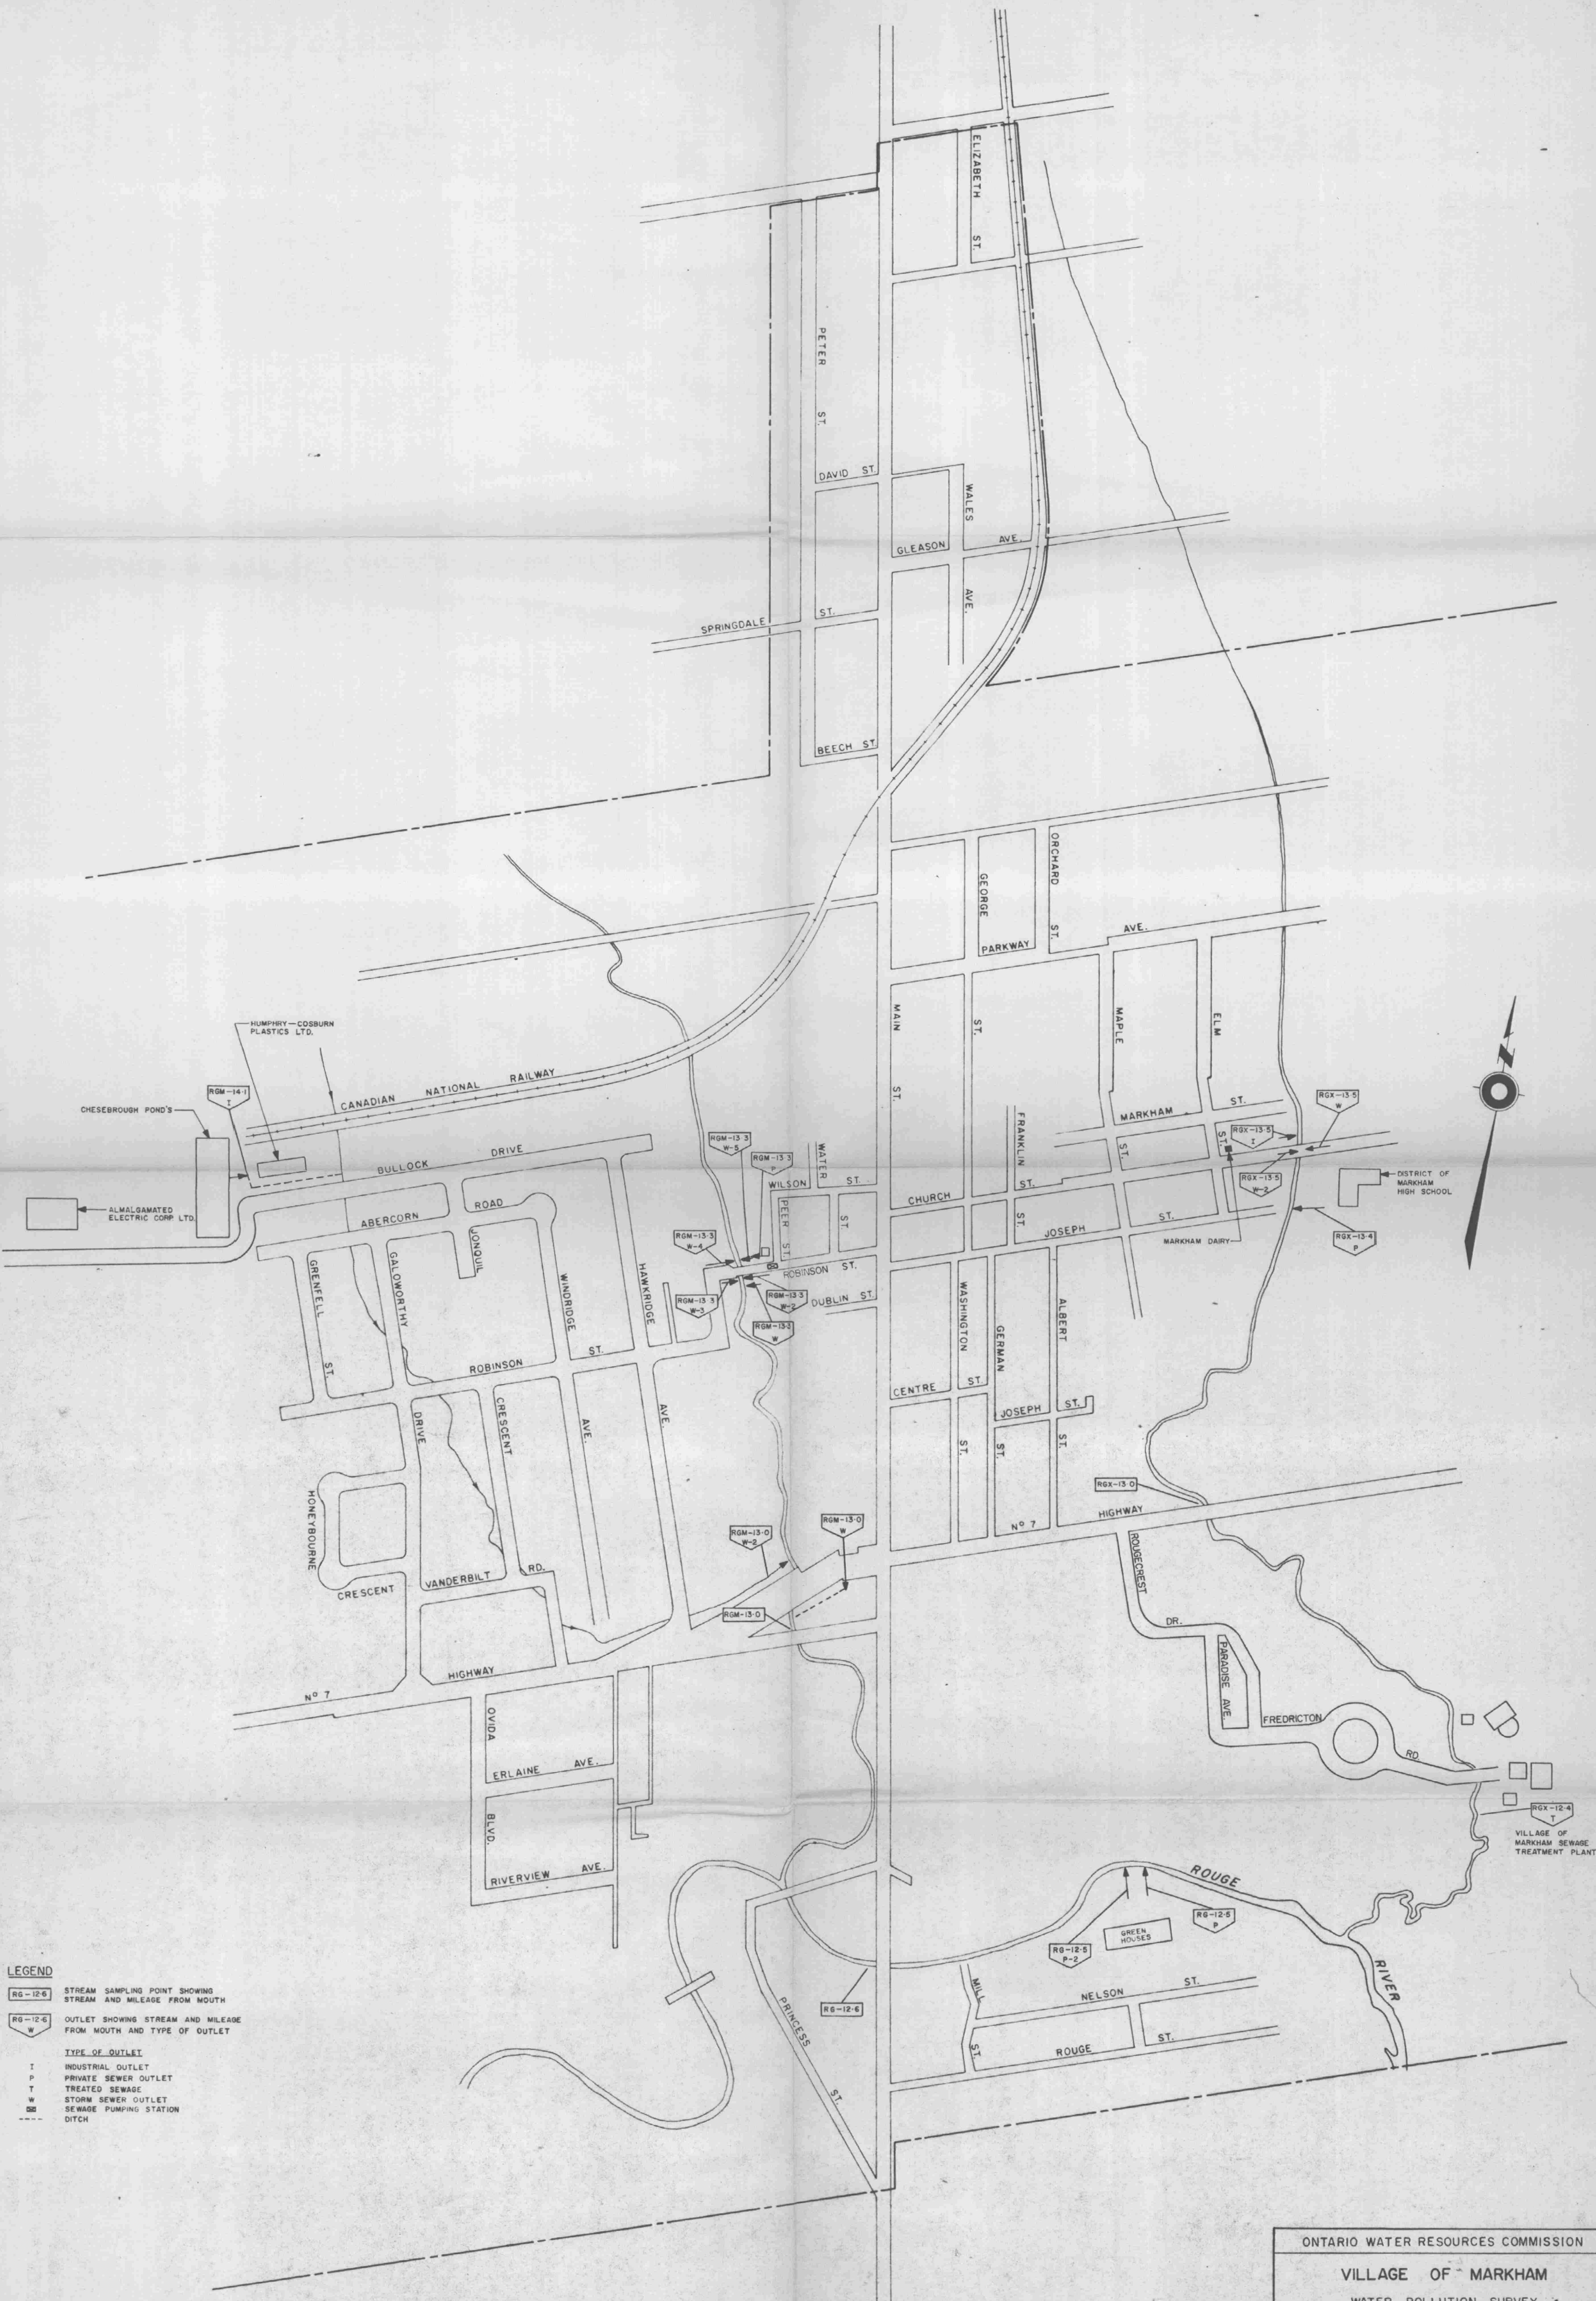
The laboratory results of the bacteriological examinations and chemical analysis of the samples collected from the two creeks that traverse this village and from the sewer outlets discharging a dry weather flow are presented in Table I which is appended to this report.
